## Discussion on the origin of surface failures in the Valley of Aguascalientes, México

M. Hernández-Marín<sup>1</sup>, N. González-Cervantes<sup>1</sup>, J. Pacheco-Martínez<sup>2</sup>, and D. H. Frías-Guzmán<sup>3</sup>

Published: 12 November 2015

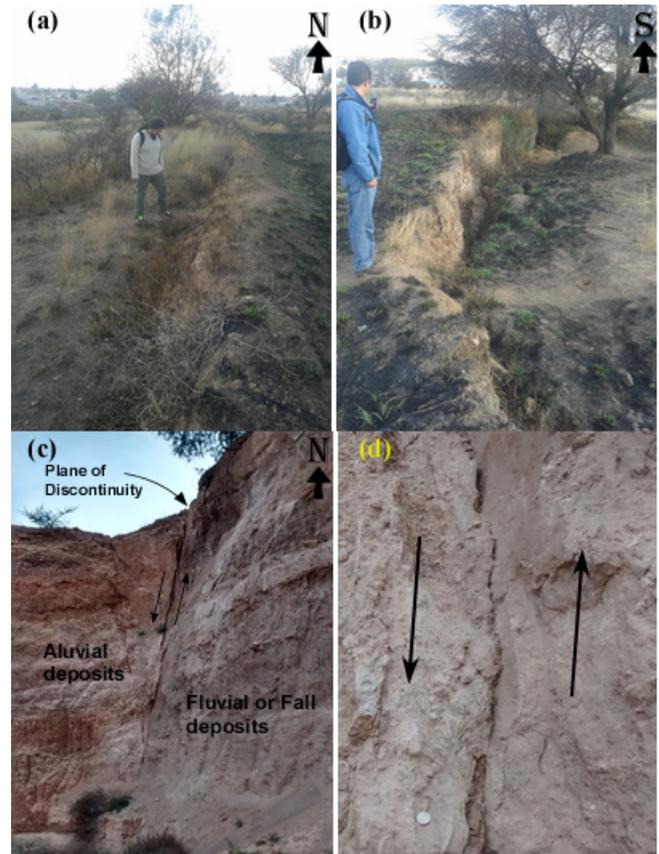
the opening is of more than 1 m and the observable depth can reach 2 m. Photographs in Fig. 2a and b show the geometric characteristics of this fault (point 1 in Fig. 1). Another important point of discussion can be observed in the quarry of Fig. 2c and d. There, figures show an approximate quarry depth of 8 m, and as observed, alluvial sediments on the left are not shown on the right, this means that there is a fault offset higher than 8 m. The fact that the fault plane cuts the entire upper sedimentary sequence indicates continuous activity of the fault in recent years. Also, the relative large fault offset may indicate that this activity started many years ago, prior groundwater pumping.

**Figure 2.** Photographs depict some characteristics of the Oriente fault inside the city of Aguascalientes. Difference between the base and the surface in the quarry in panels (c) and (d) is close to 8 m.

valley and contributed to the origin of the valley the graben, then it is easy to think that this fault is tectonic in origin. However, the discussion here is the fact that tectonic activity could continue by the early 1970's, therefore this fault might be geologically defined as active.

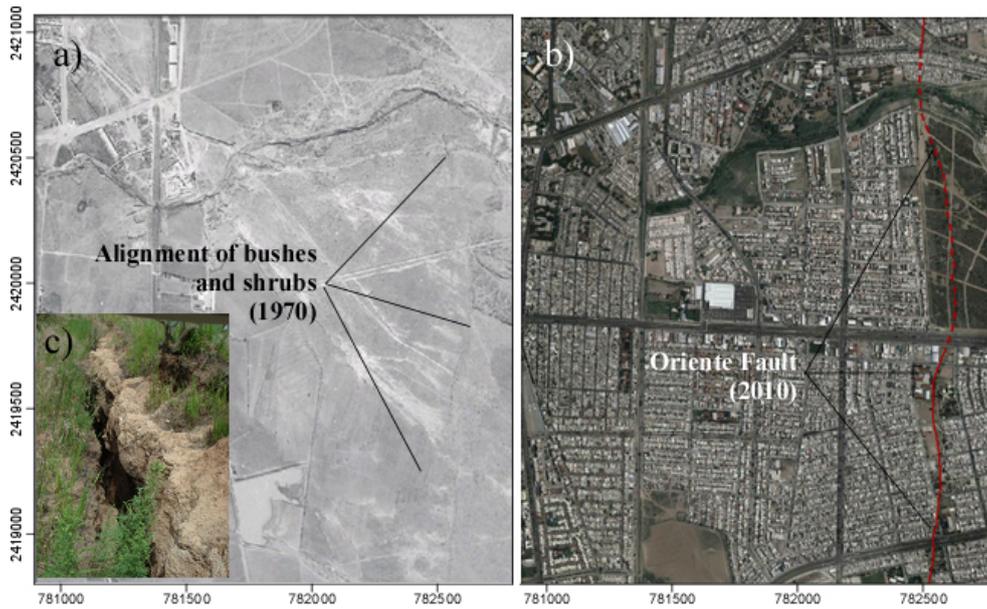
As presented in Pacheco-Martínez et al. (2013), the comparison of images containing a fault in two different years suggests that the origin of some surface discontinuities is natural, prior the pumping-induced subsidence process. In Fig. 3, the photograph of the left is from the early 1970's, before the occurrence of heavy pumping, however, the alignment of bushes clearly suggests an incipient discontinuity at the surface. It probably was well formed at depth by then. The discussion on this observation lies on the activity of this discontinuity at this particular point: since this fault flanks the

**Figure 3.** Comparison of two zones before and after intensive pumping (modified from Pacheco-Martínez et al., 2013). The particular location of this area is indicated in Fig. 1 with number 4.

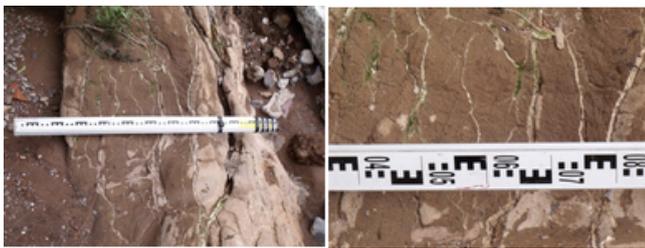
The observed refilled cracks with carbonates in the Oriente fault reinforce the idea of quaternary tectonic activity stressing on the valley, which generated faults and cracks currently reactivated due to induced stresses by groundwater decline. As discussed in Pacheco-Martínez et al. (2013), a representative 1 cm-width crack in a region with climate similar to that in the valley of Aguascalientes, can last between 100 and 500 years per linear meter to be refilled with caliche, a time sufficiently long before the initiation of heavy pumping. As observed in the figure all cracks are closely parallel between them and their orientation quite similar to that of the main discontinuity at regional scale. Point 2 in Fig. 4 shows the location of observation for these refilled cracks.

**Figure 4.** Filled cracks inside the zone of influence of the Oriente Fault. Refill consisted in groundwater caliche with a maximum thickness of 1 cm.

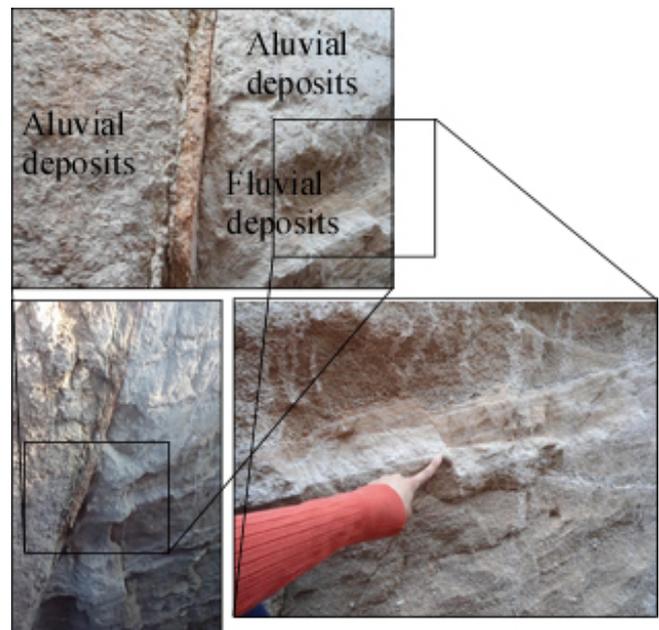
In order to elucidate on the existence of buried cracks potentially becoming in surface discontinuities, it is a common practice in the Aguascalientes Valley to excavate trenches. This activity is usually performed to complement the geophysical studies and allows either confirming or dismissing buried ground discontinuities. When a buried soil crack is confirmed, they can observe their path, describe the mechanical damage of the adjacent geologic material, and define the potential influence zone on both sides of the discontinuity. Figure 5 shows a fault cutting the upper sediments into a trench. An offset of more than 1.5 m was observed. This fault however is not the Oriente fault. This observation indicates that intra-basin faults may be also older than the pumping-induced subsidence process. This fault may represent an old fault reactivated by groundwater pumping.

**Figure 5.** Trench excavated to physically observe a fault at depth. This is point 4 in Fig. 2. Observations indicate that hanging wall seems to be on the west of the fault, not to the east, which is toward the center of the valley.
