## Discussion on the origin of surface failures in the Valley of Aguascalientes, México

M. Hernández-Marín<sup>1</sup>, N. González-Cervantes<sup>1</sup>, J. Pacheco-Martínez<sup>2</sup>, and D. H. Frías-Guzmán<sup>3</sup>

Published: 12 November 2015

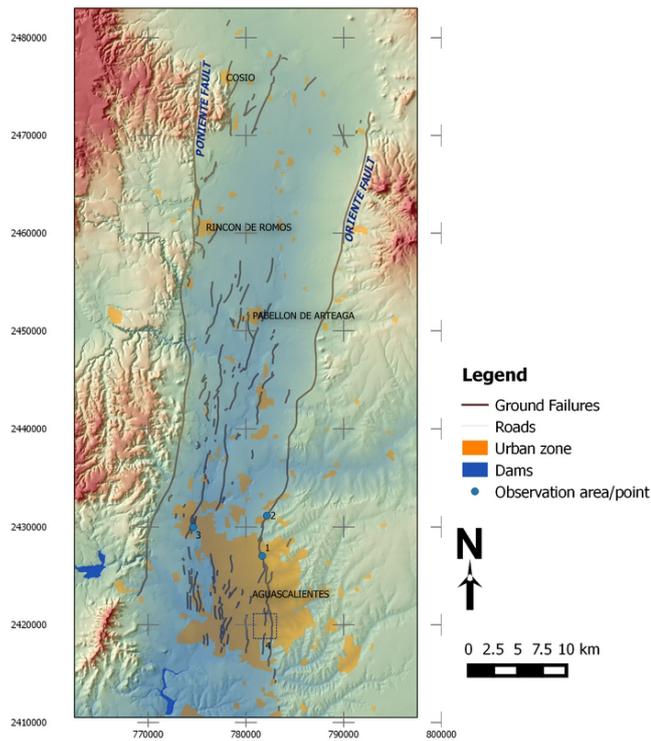
The named Oriente Fault (oriente means eastern in Spanish), flanks the Aguascalientes valley on the east, as observed in Fig. 1. In some branches, this fault is observed as a fissure and in others as a fault. In few locations is not shown at the surface (hidden by recent sediments?), but in others is observed as parallel alignments of two or three discontinuities. It is one of the most active in the valley, as evidence of that, the paved crossing roads over the trace failure trace are continuously repaired. It is also one of the most affected surface discontinuities by weathering because in some points,

**Figure 1.** Main features of the Aguascalientes basin. Areas and points of observation in the map are referred according to figures: point 1 to Fig. 2, area 4 to Fig. 3, point 2 to Fig. 4, and point 3 to Fig. 5.
